GERS_073_1 IRAN

Comparison between the archive (QuickBird 24/12/2009) and the post event image (Ikonos-2 23/12/2010)

Using this pair of images : no obvious damages are detected within the AOI covering Nematabad area.

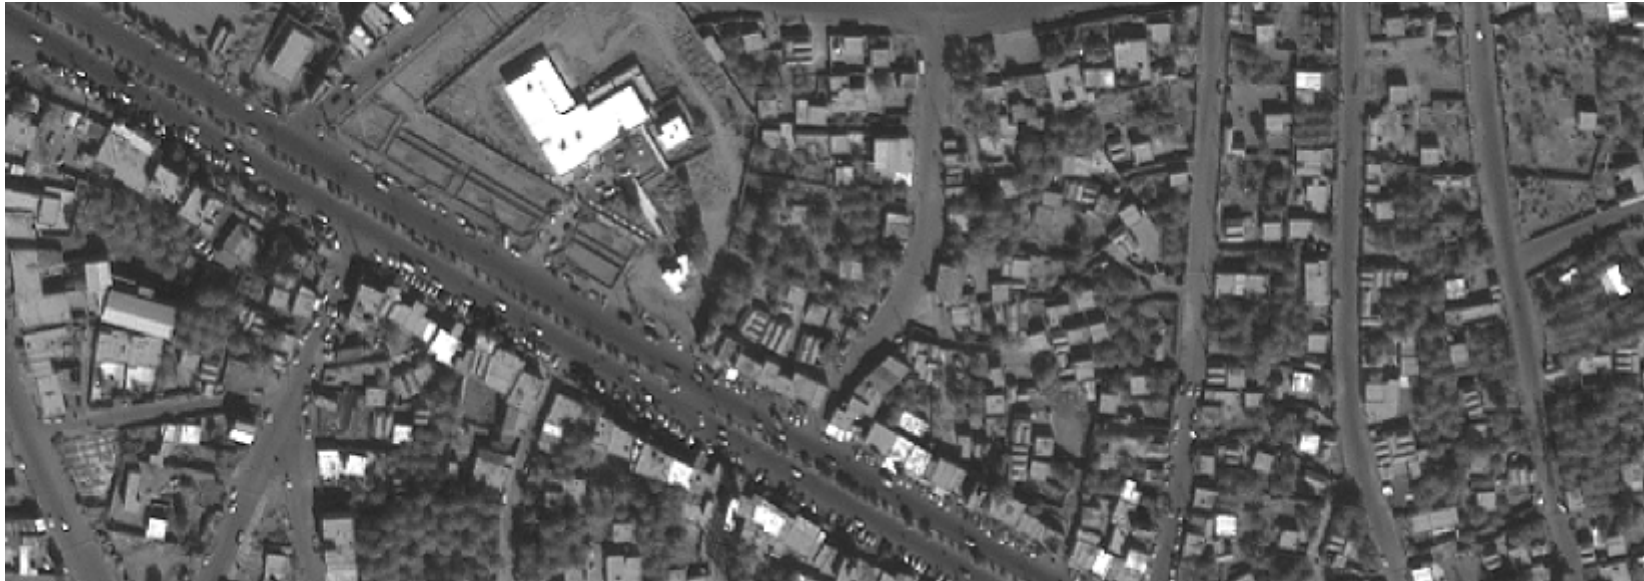
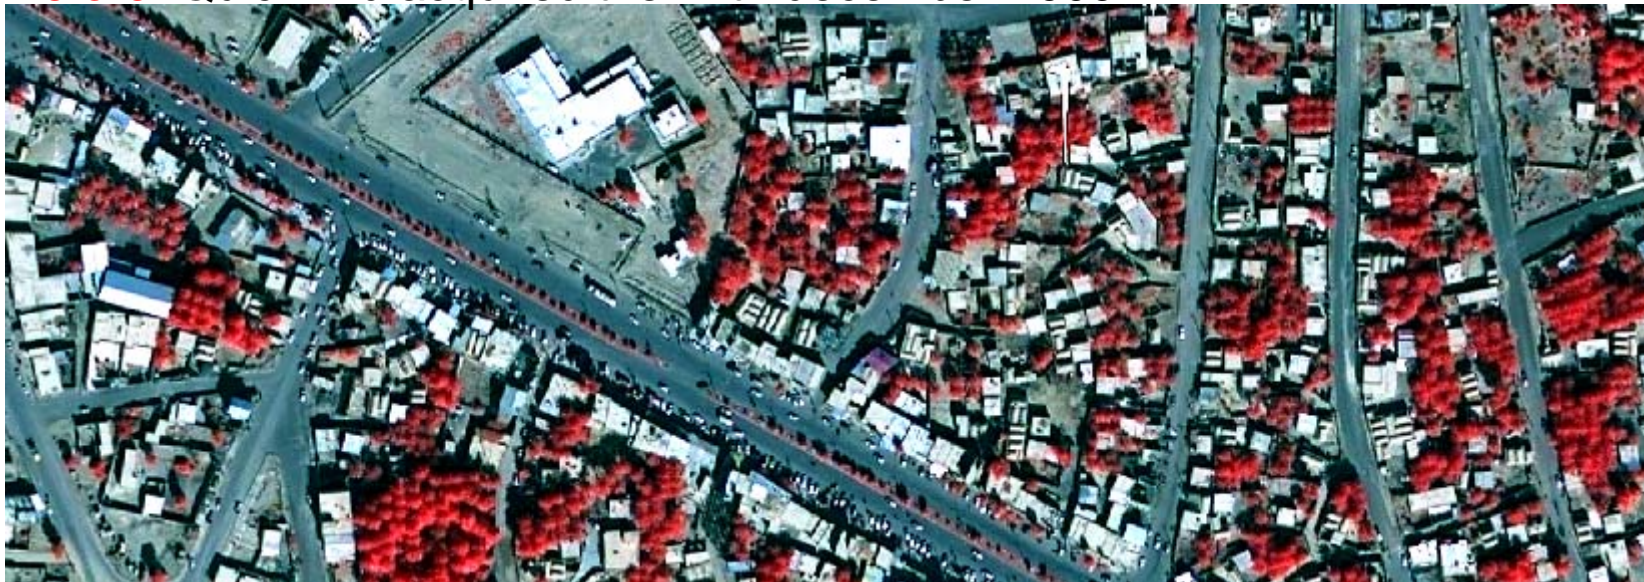
After: IKONOS-2 acquired the 23rd december 2010

Rigan central avenue similar traffic and parking; globally no difference in population activity has been observed

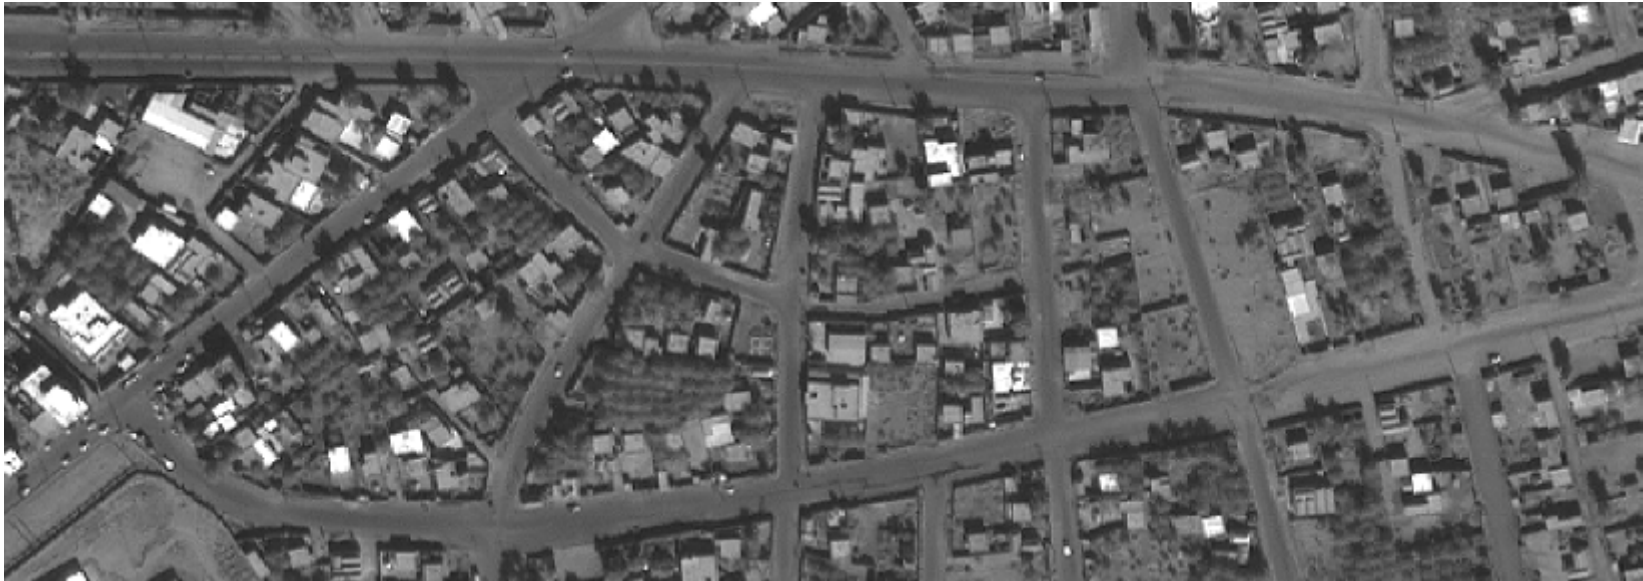
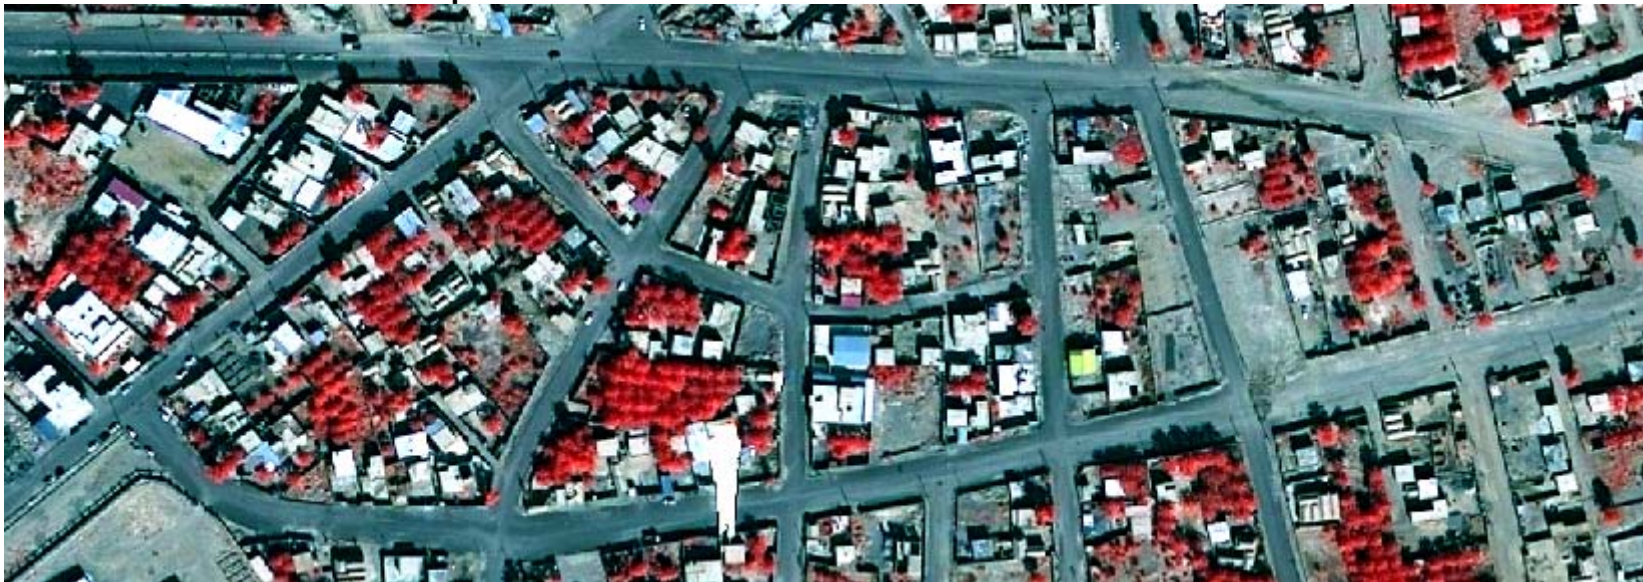
After: IKONOS-2 acquired the 23rd december 2010

Streets are clean before and after; globally no difference
in population activity has been observed

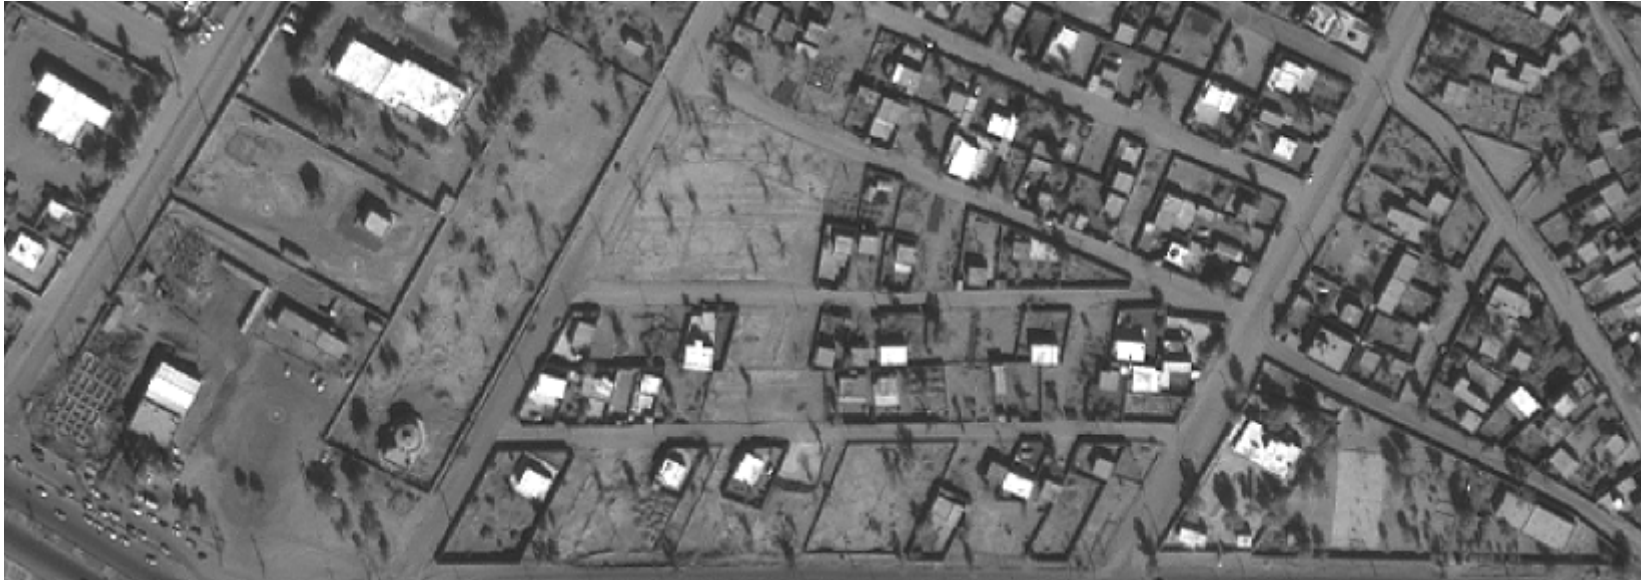
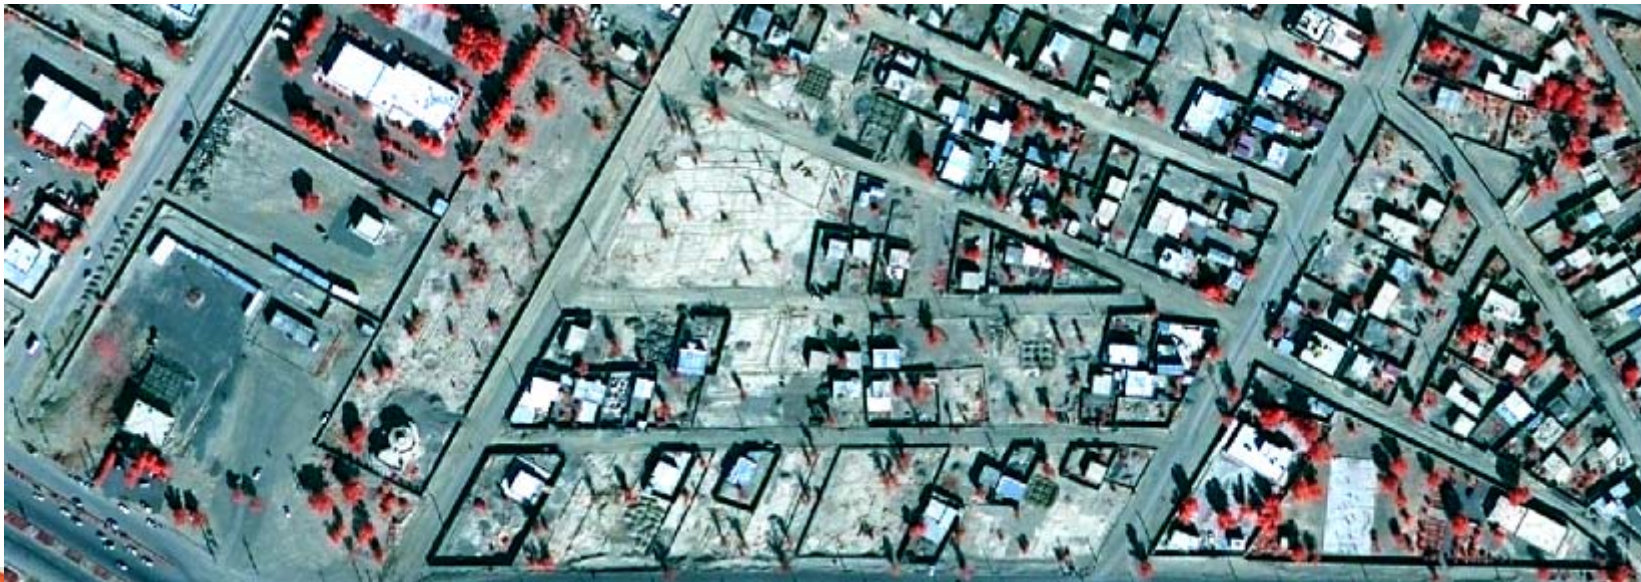
After: IKONOS-2 acquired the 23rd december 2010

No damages observed in the numerous fence walls
(highlighted by the linear shadows)

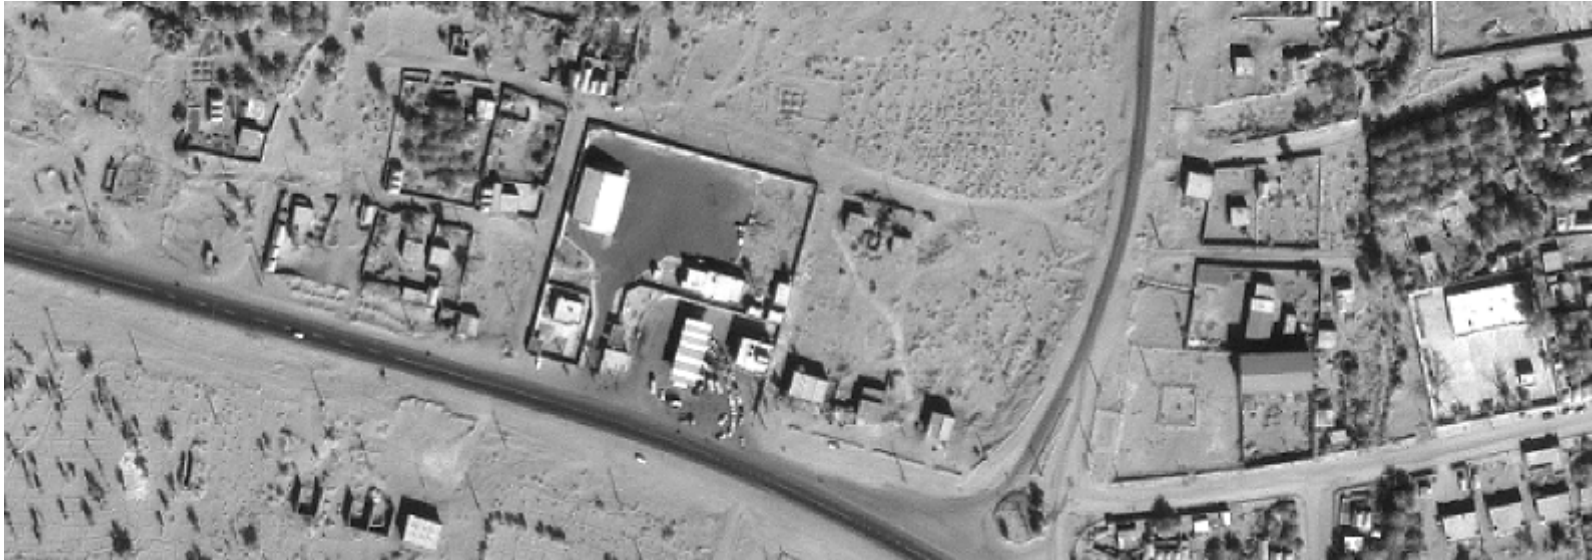
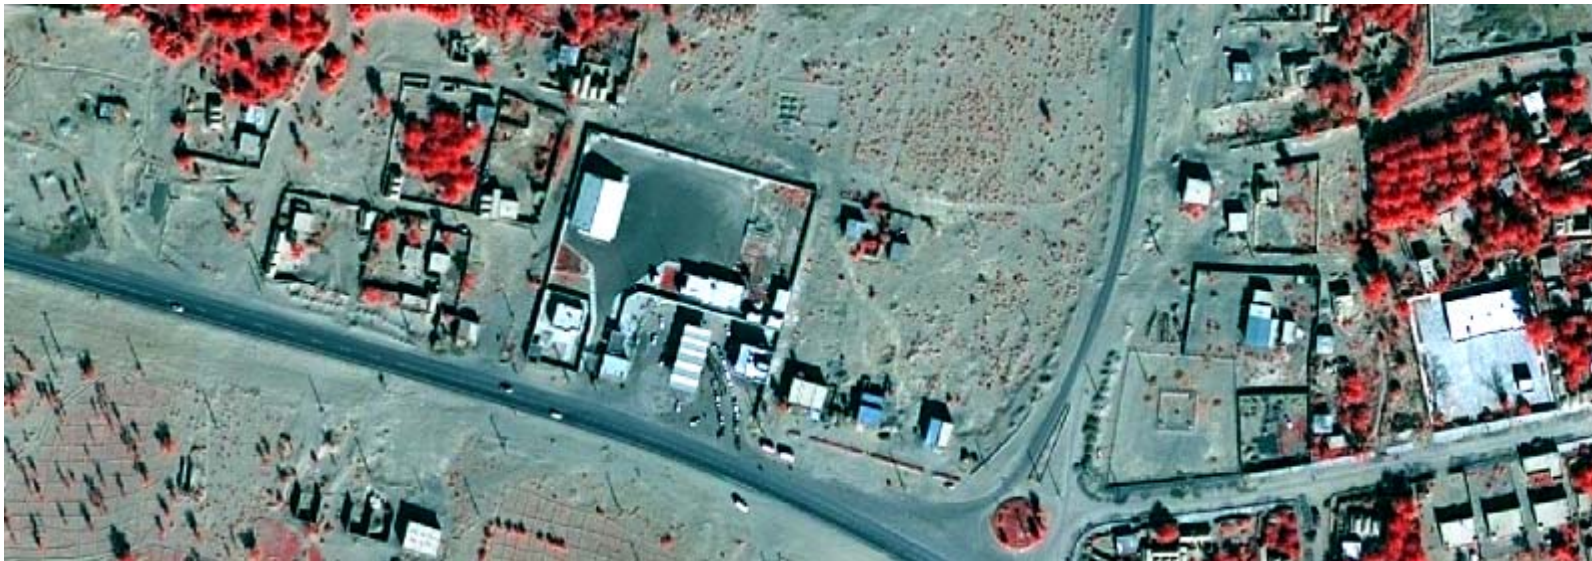
After: IKONOS-2 acquired the 23rd december 2010

Gas station seem to be still working

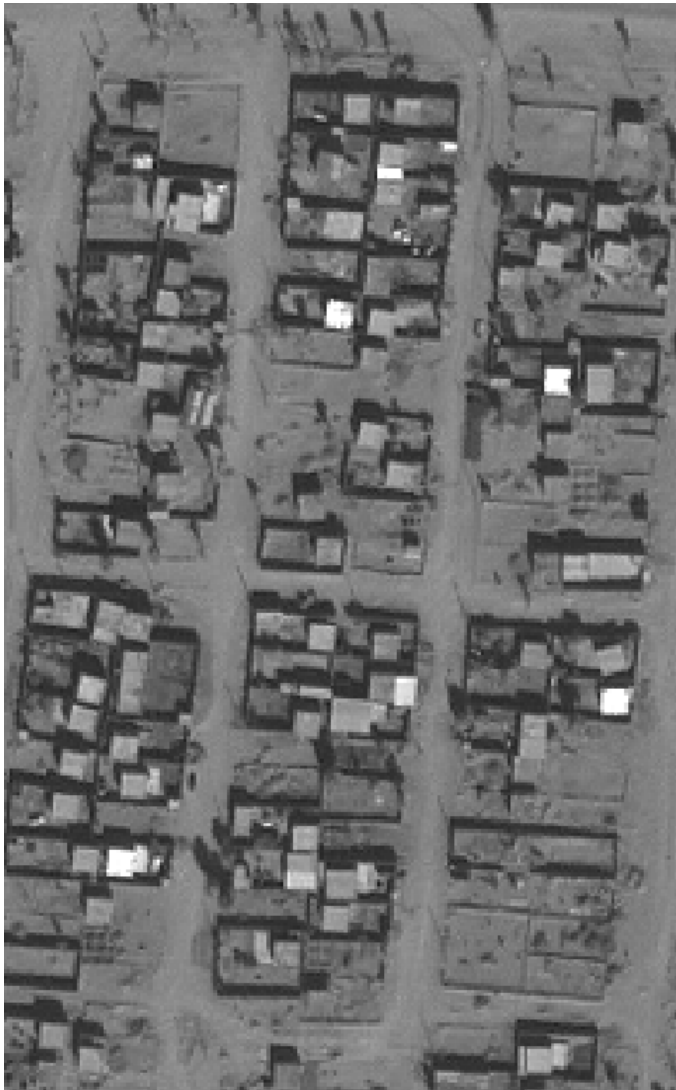
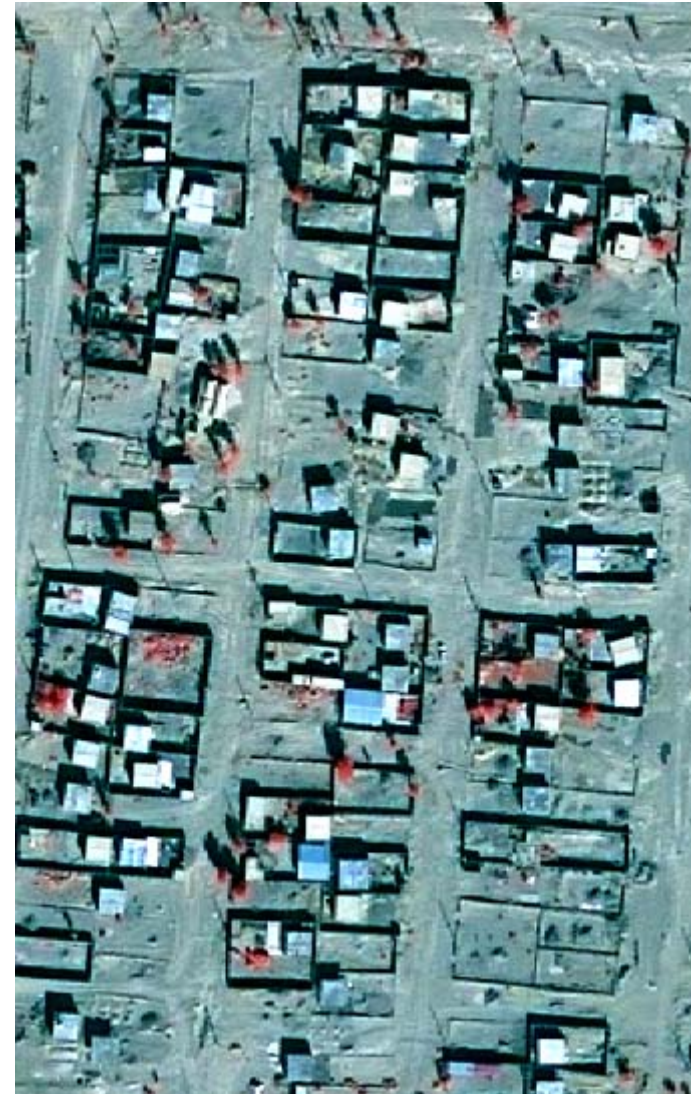
After: IKONOS-2 acquired
the 23rd december 2010

No difference is observed in the urban blocks
