Tsunami Chile Change Detection

A rapid investigation by RapidEye

Product Development / RapidEye Brandenburg / March 4th 2010

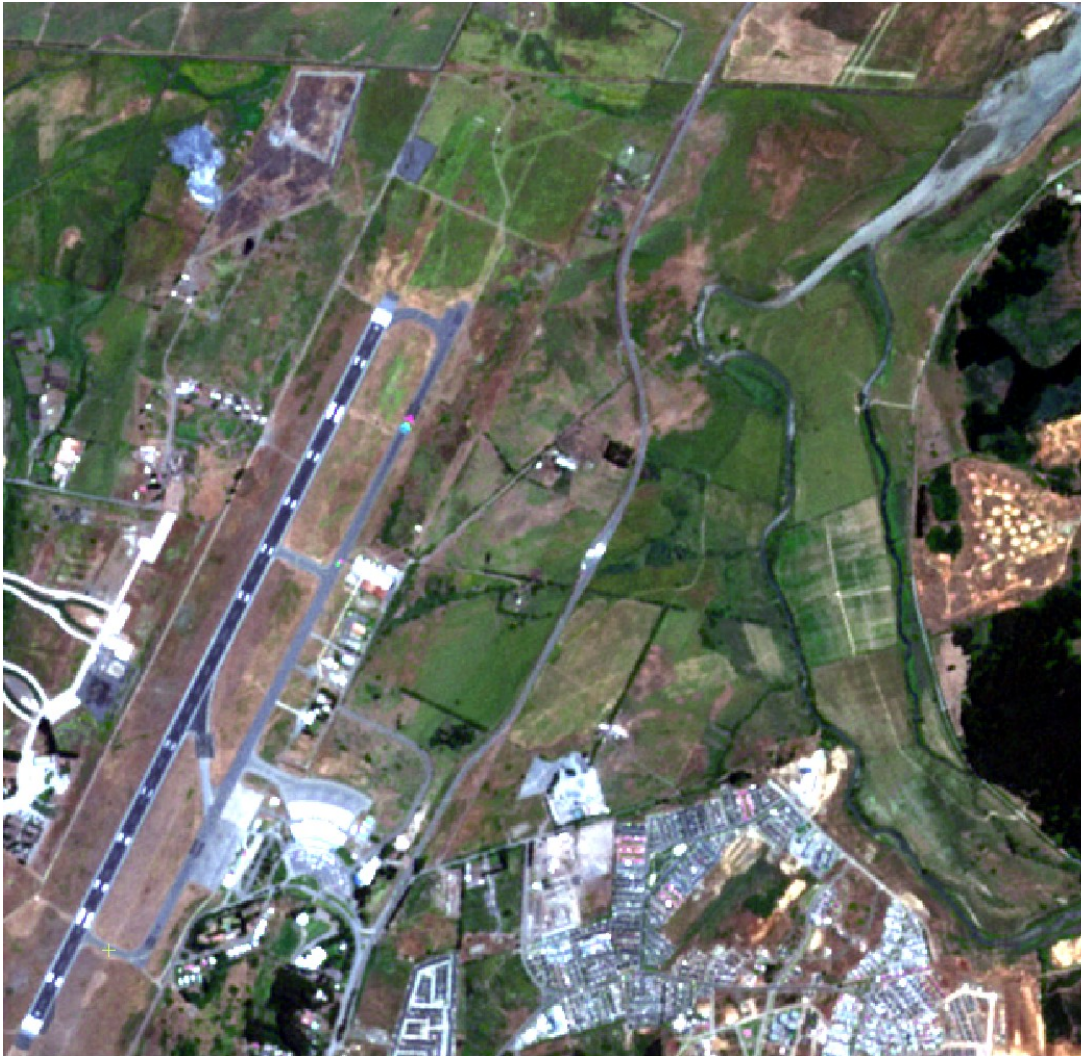
Close Up Detail - Case #1

- > Concepcion Airport
region: 2010-01-22

- > The image shows changes in the vicinity of the airport.
- > Note, the changes of airport buildings.

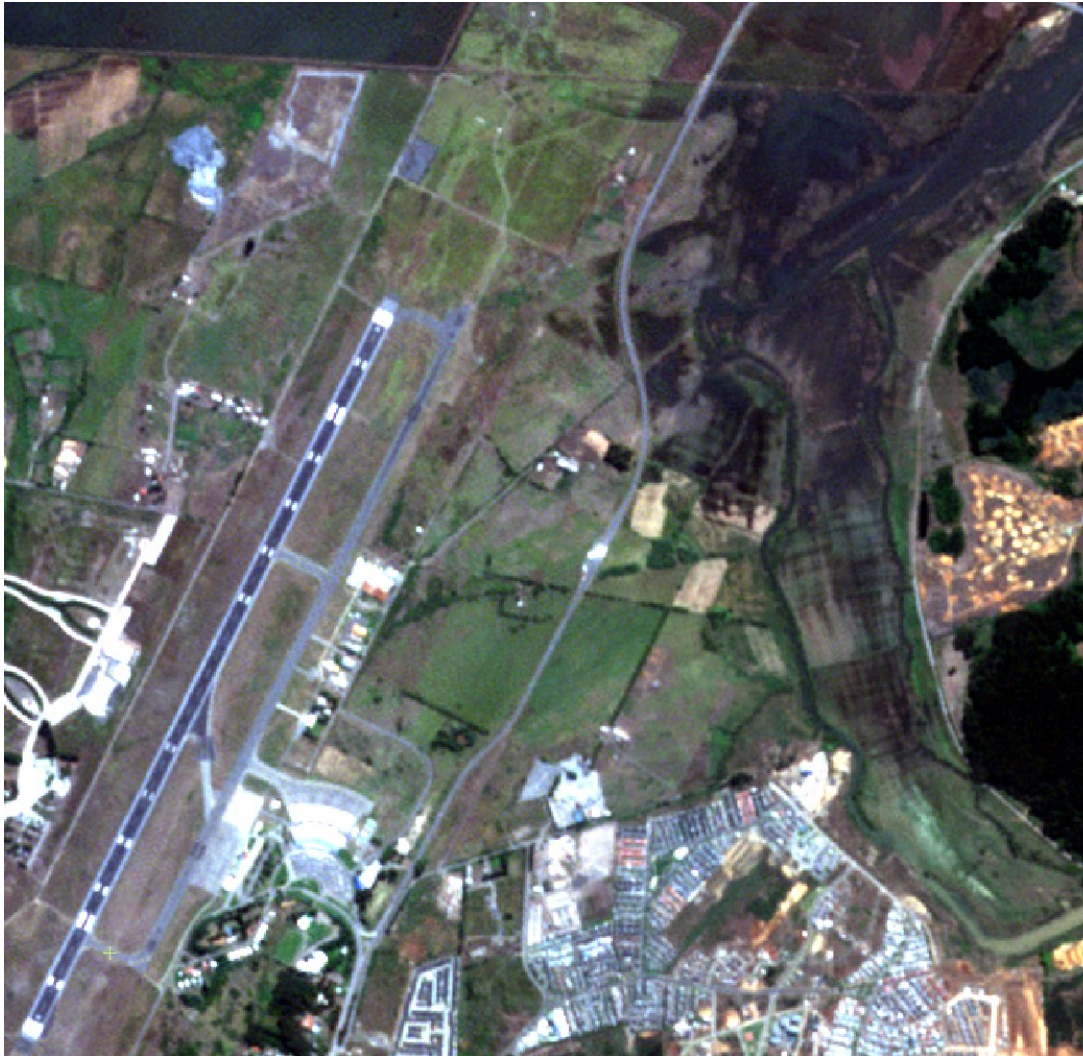
Close Up Detail - Case #1 – After earthquake

- > Concepcion Airport
region: 2010-02-27

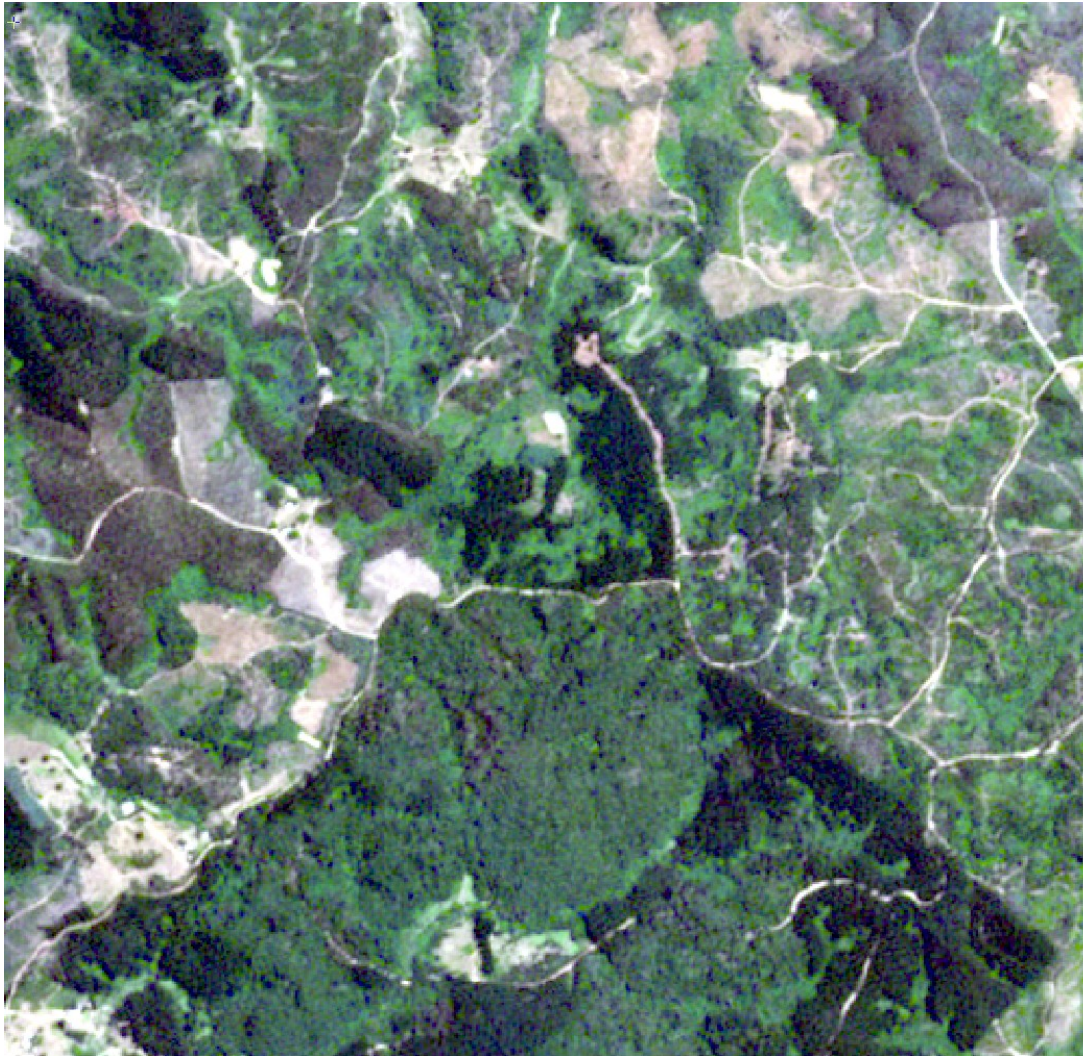
Close Up Detail Case #2

- > Forested region outside of the city with steep slopes: 2010-01-22

- > The dramatic wide spread change to the landscape is likely a landslide. Even the road was changed.

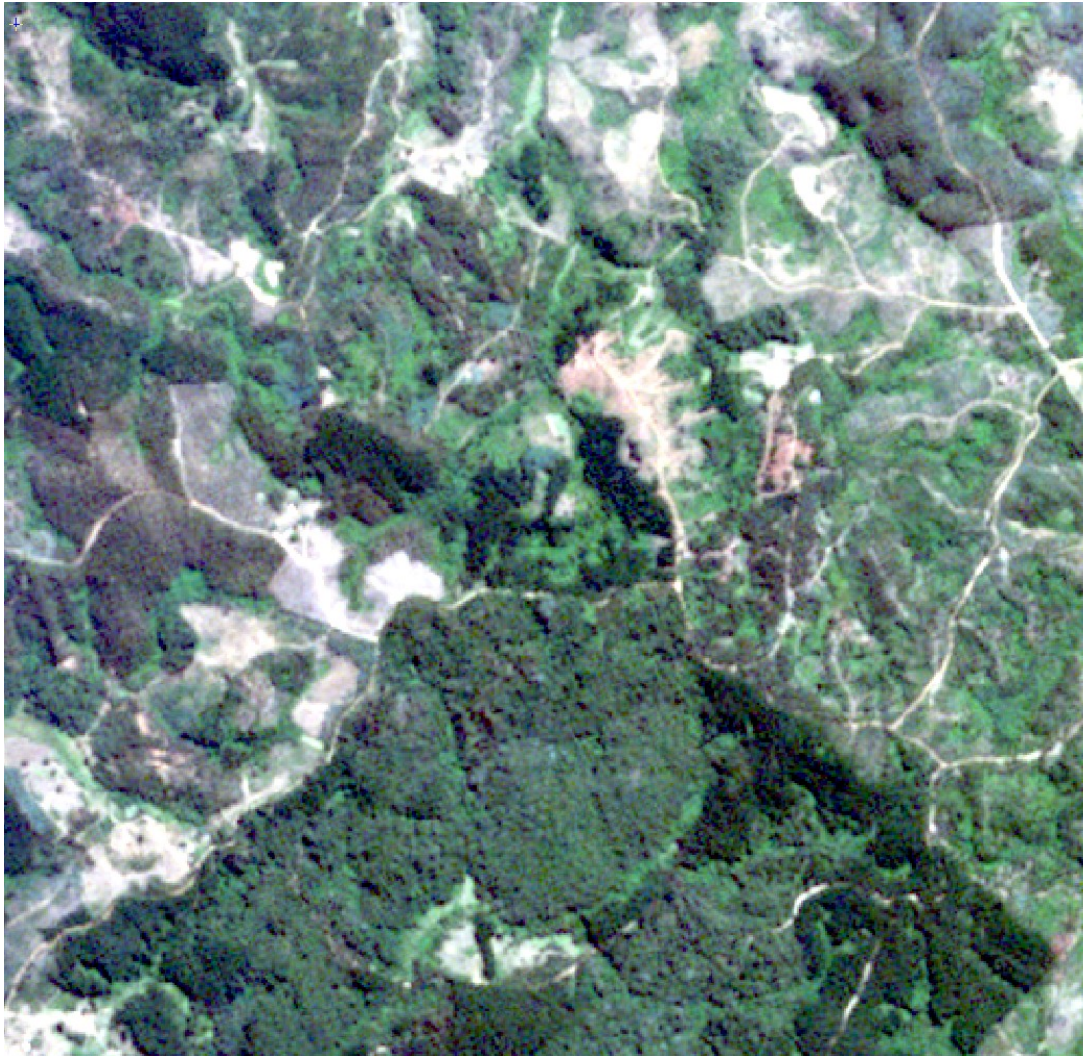
Close Up Detail - Case #2 – After earthquake

- > Forested region outside of the city with steep slopes: 2010-02-27

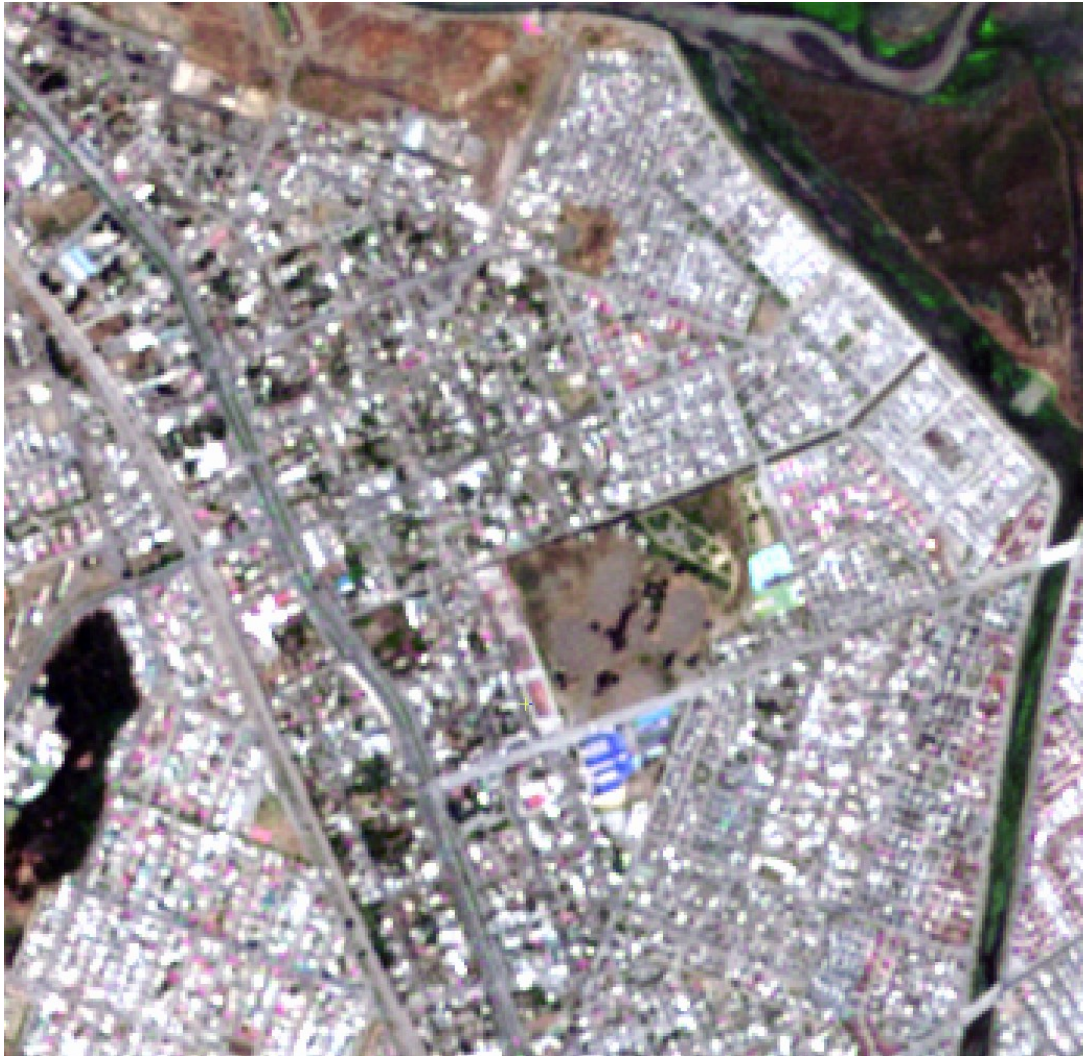
Close Up Detail Case #3

- > Details of the urban area imaged on 2010-01-22

- > Details of the urban area imaged on 2010-02-27
- > The dark colored water is clearly seen between the urban structures reaching far between the houses.

- > Changes made visible. The exact impact of those changes need to be assess on the ground. The information is useful to direct ground staff to the right location.

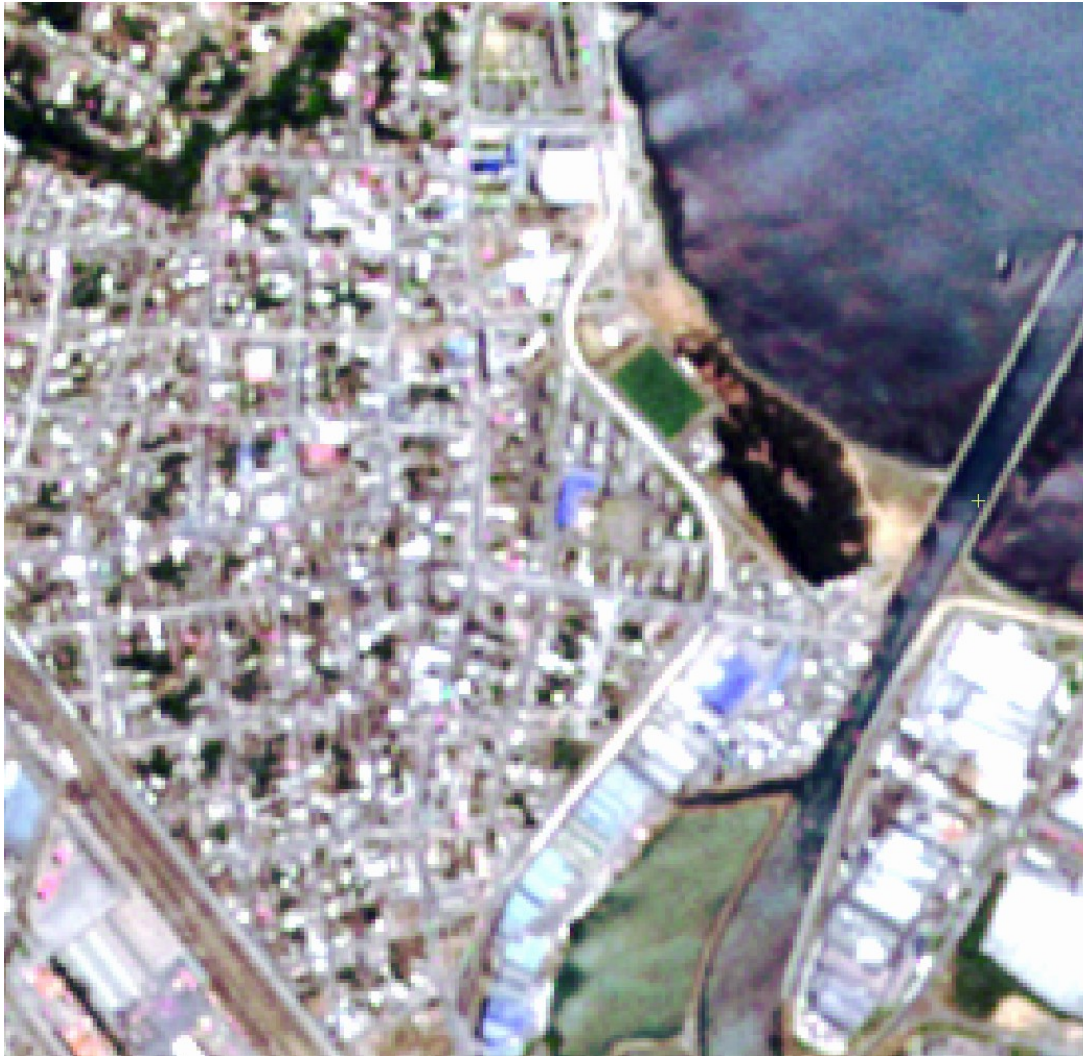
Close Up Detail Case #4

- > Coastal area and coastal road as imaged on: 2010-01-22

- > The road and one large building have clearly been damaged.

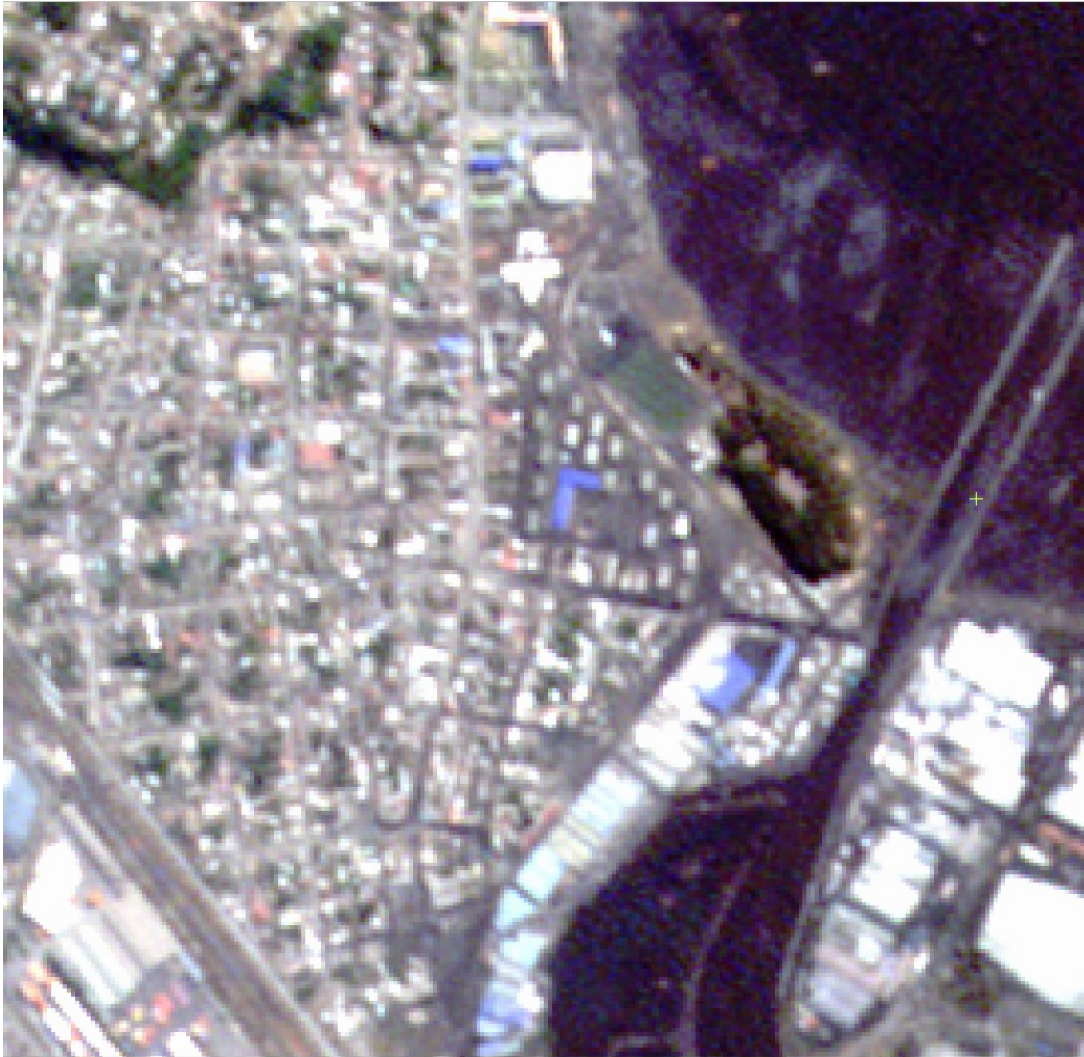
Close Up Detail - Case #3 – After earthquake

> After damage.

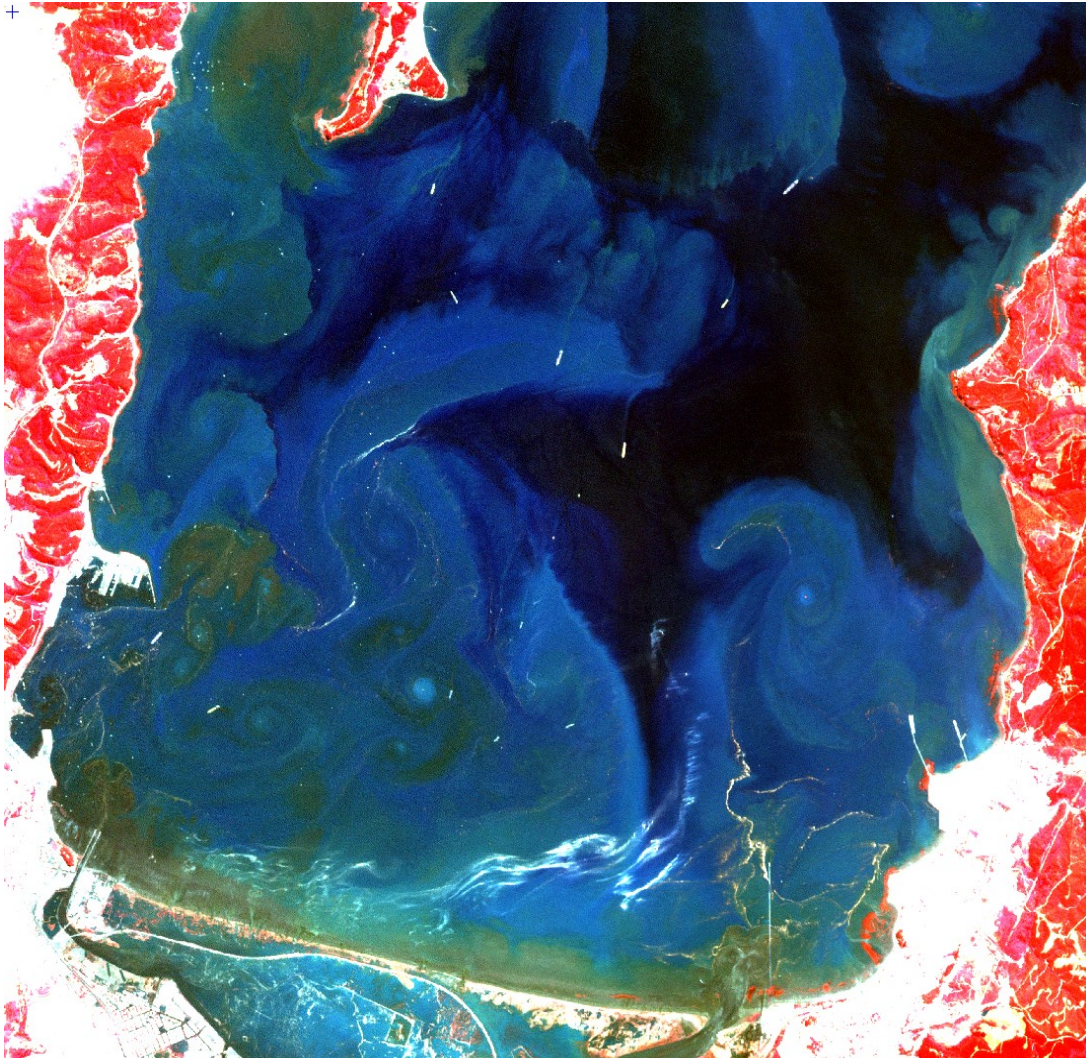
Close Up Detail Case #5 – Oceanic disturbances after earthquake

- > The image taken a few hours after the earthquake clearly shows the currents within the waterbody.
